FROM: Srikanth S. Holikatti and Douglas J. Frith
DATE: October 1, 1997
SUBJECT: Suspension of SMP Site Monitoring Activities, Site 320101

This memo will serve as the SMP Site Monitoring Activities Suspension Status Report for Site 320101(32SA) near Battle Mountain, Nevada.

SECTION 320101
Battle Mt., NV

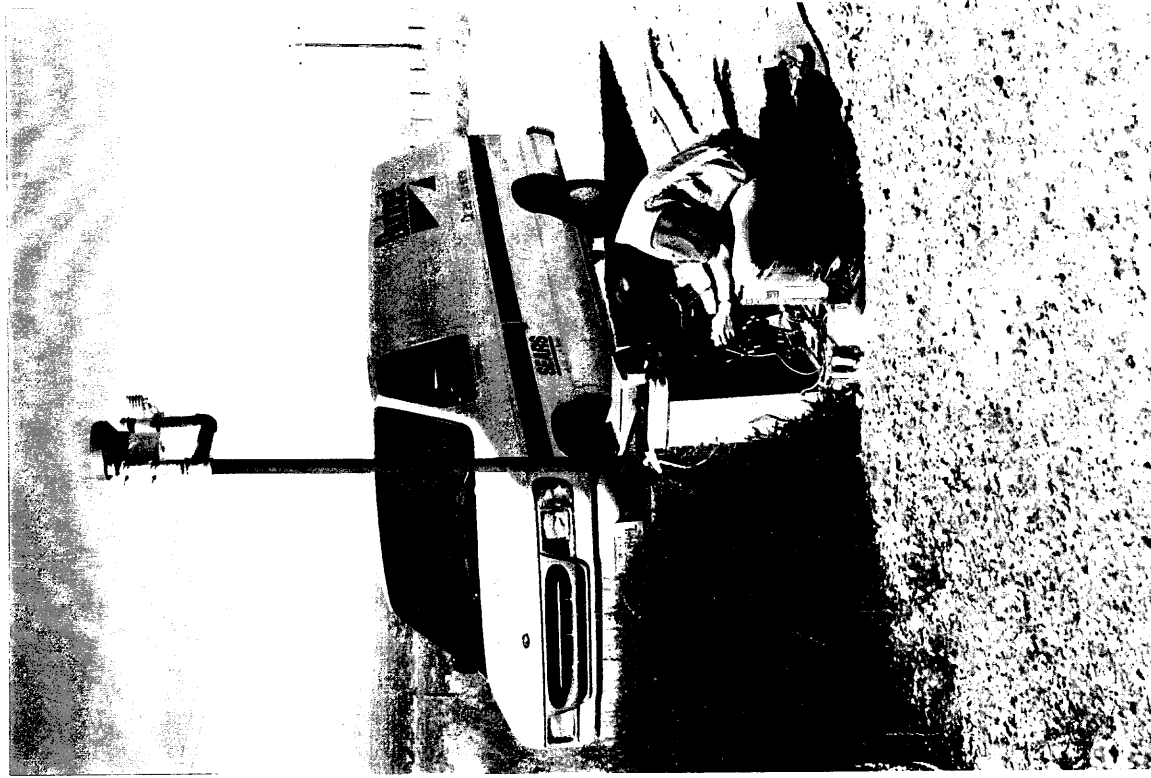
Photo 1. Last set of data collection in progress.

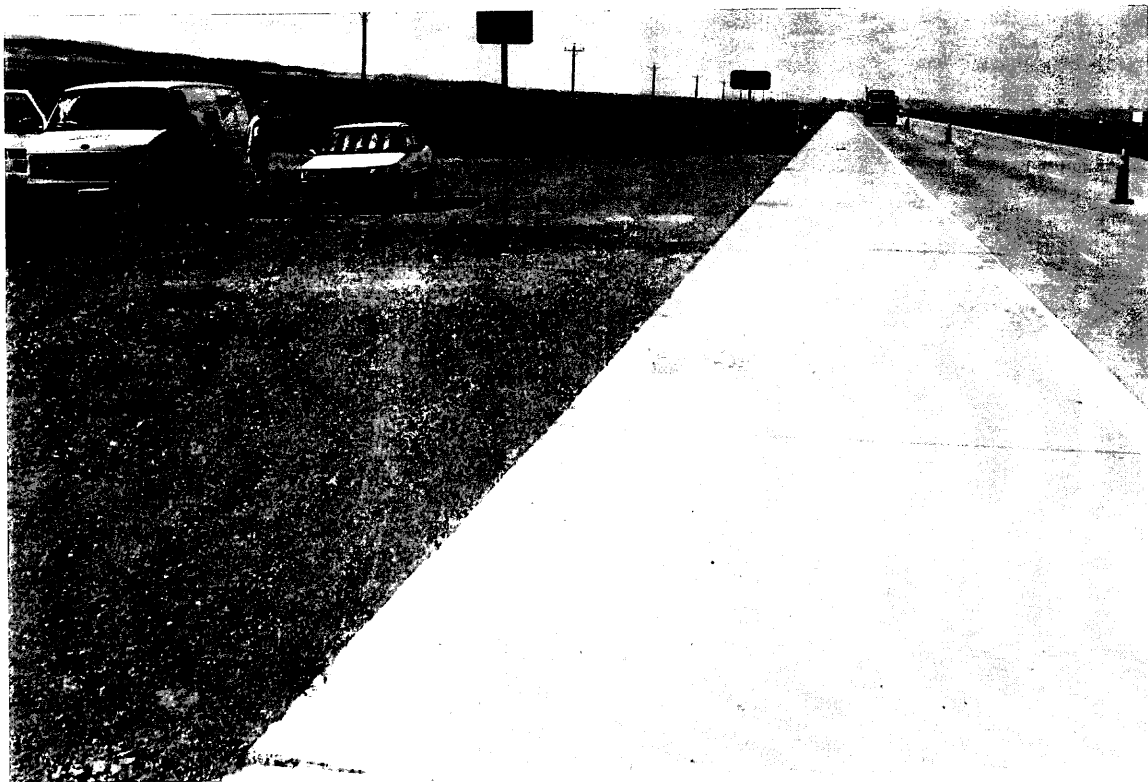
Photo 4. The instrumented area after dismantle.

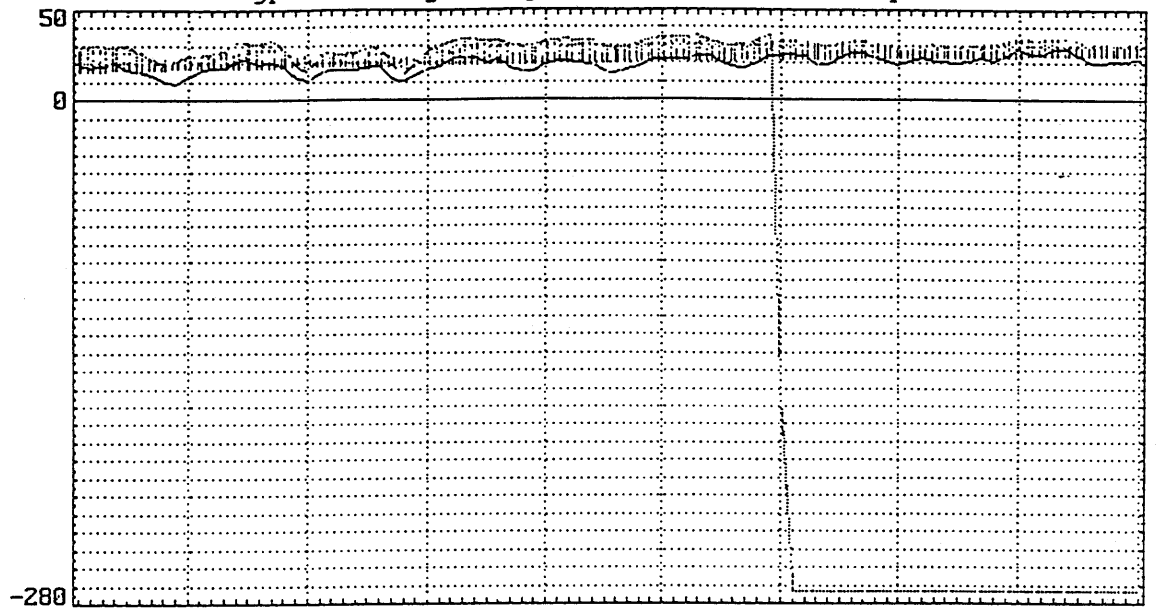
Nevada Site: A
Record Type 2 - Daily Average Air & 18 MRC Sensor Temperatures (°C)

Evaluation of data collected during the dismantle activities indicates that thermistor sensor unit one (sensors 1, 2, and 3) are dysfunctional (recording -230 C temperature). We have reason to believe that the cables from unit #1 were damaged during the instrument hole patch replacement on July 15, 1997. We intend to investigate the extent of damage, and the possibility of repairing the damage prior to reinstallation of monitoring equipment at the site.

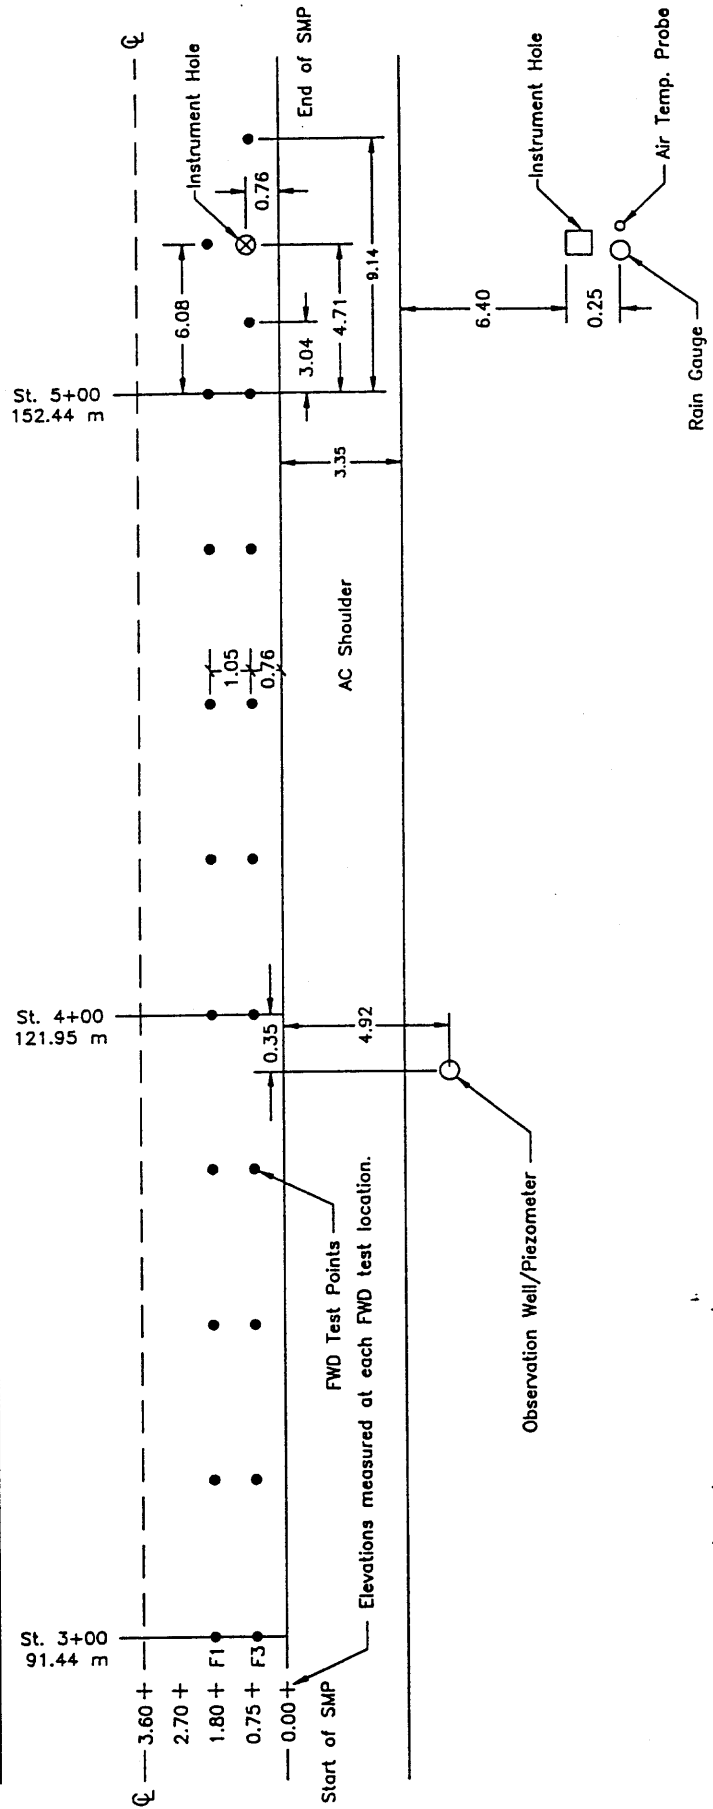
The instrumentation hole is located 157.15m from start and the instrument box is located at a distance of 9.75m from the lane edge. The piezometer is located 121.6m from the beginning of the section 4.00-0.35m at an offset of 4.92m. Please refer to the enclosed layout schematic.
